Friends of Poynton Pool C/o The Civic Hall Park Lane Poynton Stockport SK12 1RB

20 December 2023

STRUCTURE OF THE DAM EMBANKMENT AT POYNTON POOL

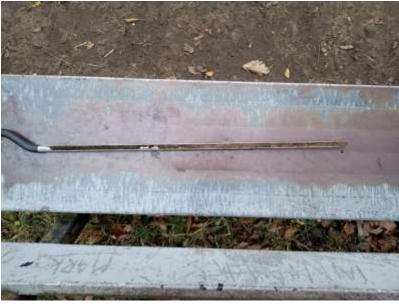
PH1

- PH1. example sample in the corer
- PH2. A small but sample of straight from corer.
 - 1) compressed bead of orange-brown clay,
 - 2) 2 & 3)rounded gravel up to 10mm
- PH3. Partially dried sample from sample in PH2, having been gently rolled by fingers. Very sandy with a high percentage of fine gravel 1cm dia and smaller
